**Saint Mary's**  
University

## **Monitoring Seasonal Changes in Surface Elevation of Intertidal Environments near the Windsor Causeway**

Dr. Danika van Proosdij  
Department of Geography

May 18, 2005

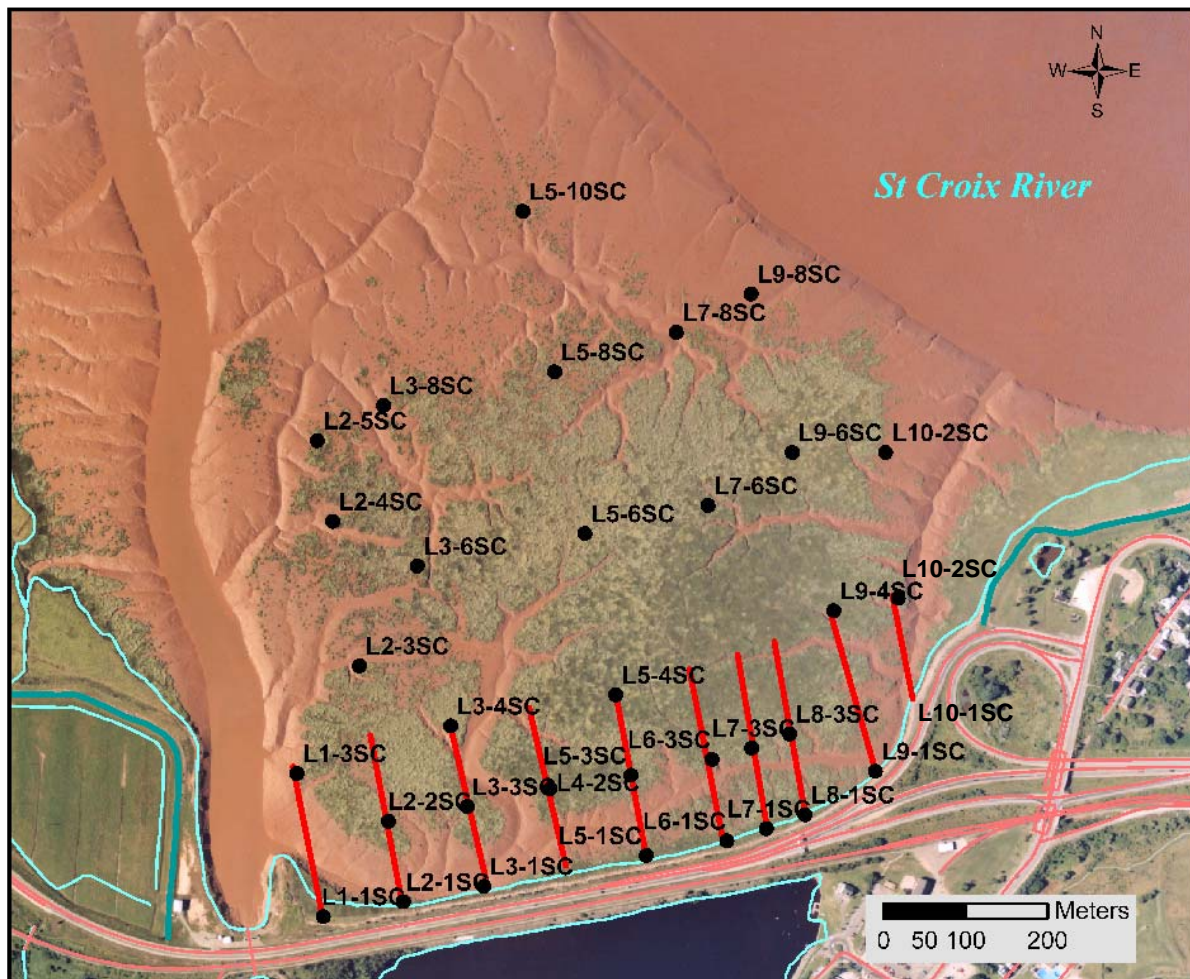
**Figure 1:** Location of sampling lines over 2003 aerial photograph. Topographic survey lines indicated in red.

Detailed topographic surveys along existing lines (Figure 1) were conducted using a Leica TCR Reflectorless Total Station set relative to a known geodetic benchmark in June, 2004. This instrument has a precision of 2 mm. However, given the difficulty of surveying within this unconsolidated environment, survey results will likely only be accurate to  $\pm 5$  cm. All elevations are expressed as orthometric heights relative to datum (CGVD28) using the HTv2 geoid model. Additional shorter surveys were conducted perpendicular to the causeway over a distance of 200 m in November, 2004. These cross sectional profiles were analyzed using Excel and incorporated into ArcView 8.3 and associated extensions to derive volumetric estimates of sediment deposition and erosion. In addition, winter sediment dynamics (such as movement of ice floes and vegetated root mats) were observed using digital photography and/or direct field observation.

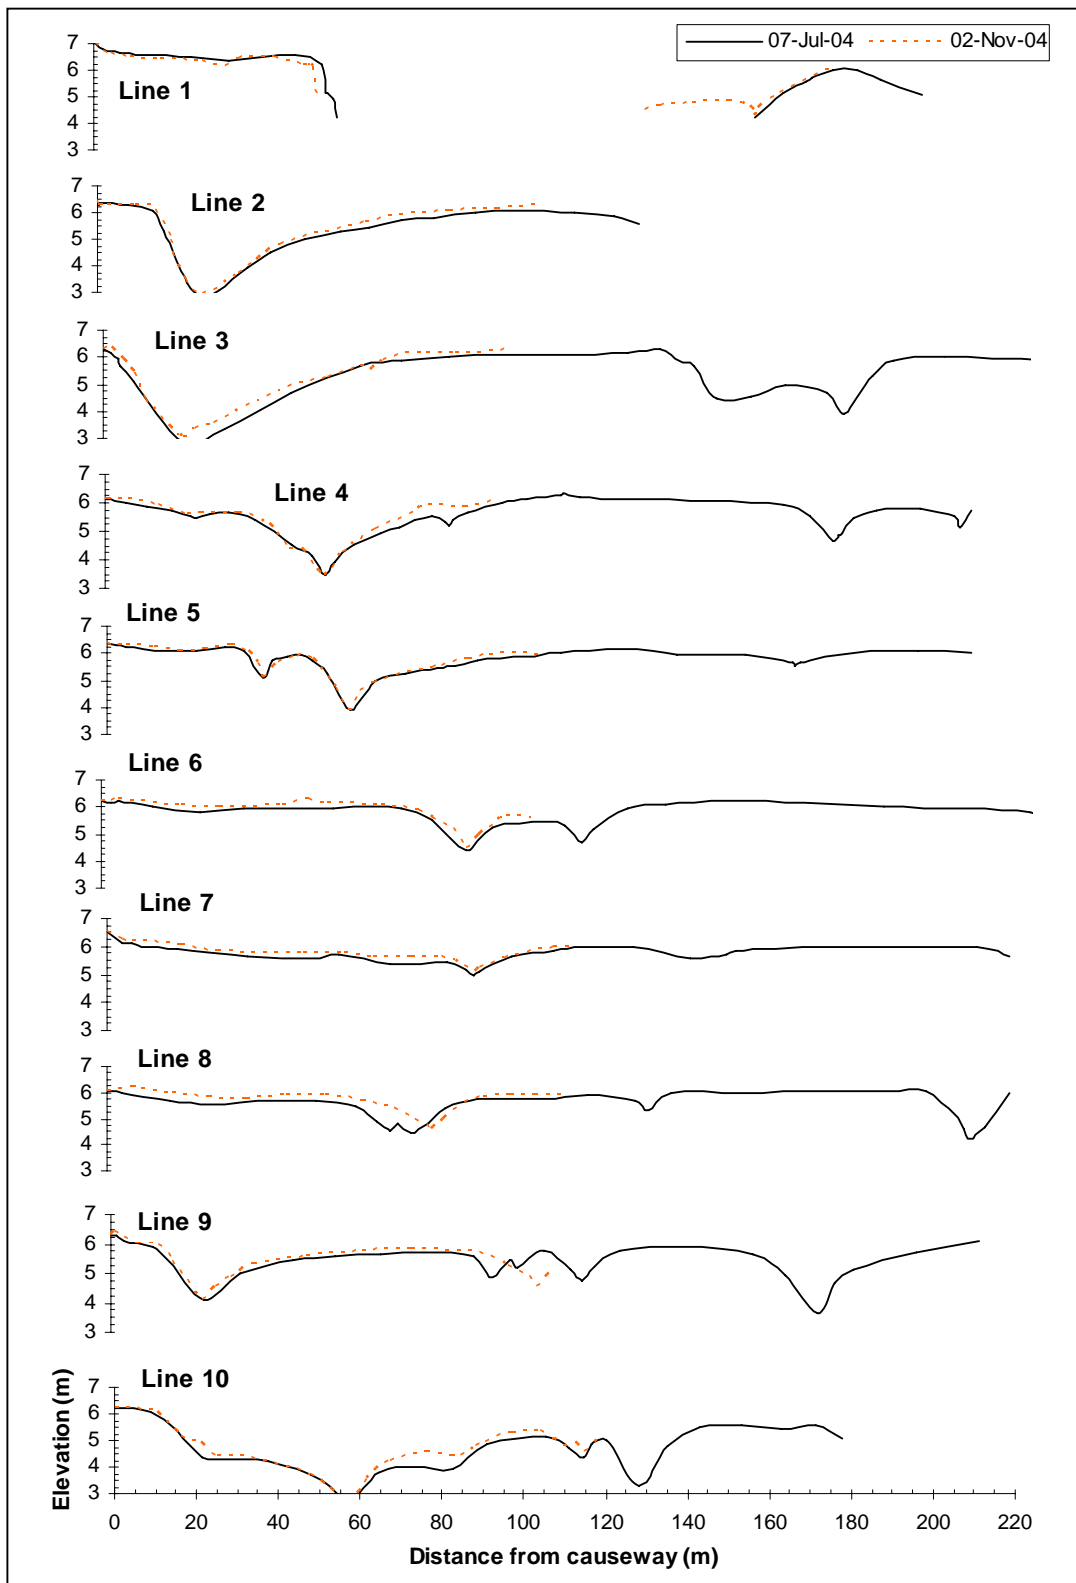
**Figure 2:** Comparison of topographic profiles surveyed in June and November 2004. Distance measured from base of causeway on marsh surface. Elevation is measured relative to MSL as defined by the CGVD28 datum.

(Table 1). The net change along all lines is positive suggesting an additional source of sediment, and although sediment is eroded in sections (Figure 2), this material is likely deposited within the immediate area.

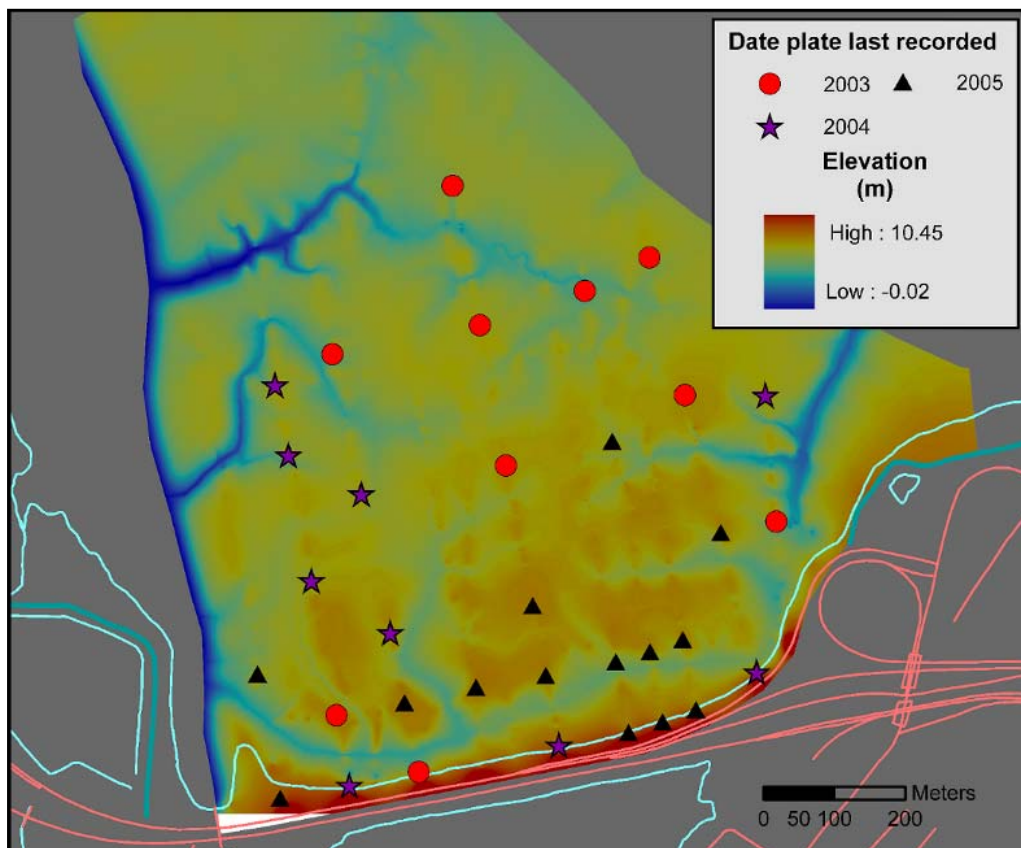
**Figure 3:** Map indicating 'survival' of plate stations over Winter 2002-03, 2003-04 and 2004-05. A total of 9 plates were lost in 2002-03, 9 in 2003-04 and one in 2004-05. Points are draped over digital elevation model developed by G. Baker in 2004 using TopoGrid command in ArcInfo. Fifteen plates were re-installed during the summer of 2005.

A total of fourteen plate stations were able to be measured in June 2004. Nine plates were not able to be re-located most likely due to ice scour and plucking as evidenced by marks remaining on the marsh / mudflat surface. These were located primarily along lines 2 and 3 near the Avon River channel and line 10 (Figure 3). The exceptions are L5-1sc and L9-1sc which likely are buried to a depth greater than the measuring rod as evidenced by the thick layer of sediment over top of the vegetation.

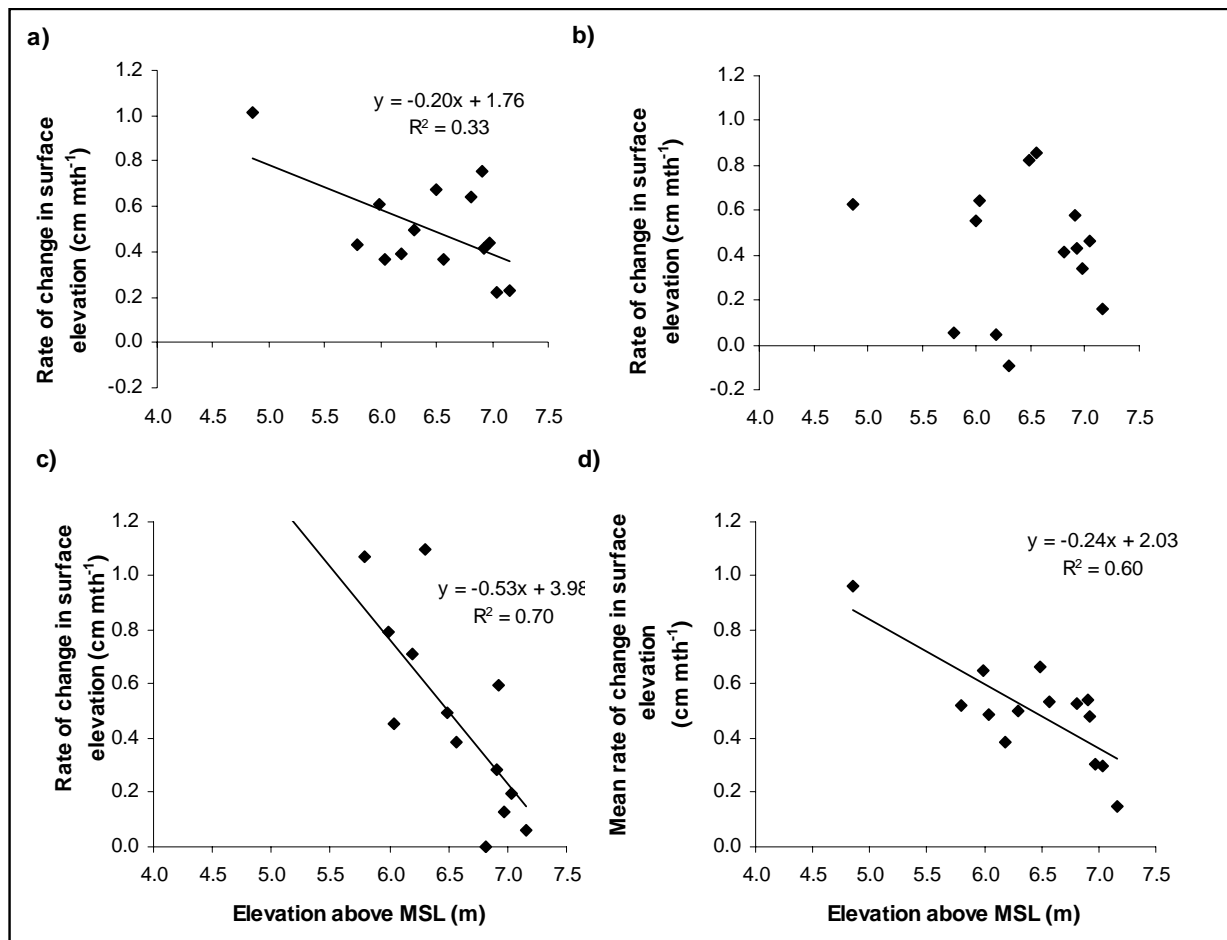
**Figure 4:** Rate of change in surface elevation in relation to elevation of the station location above sea level from a) May 7, 2003 to June 8, 2004 ; b) June 8 to November 23, 2004 and c) November 23, 2004 to May 2005. The mean rate of change in surface elevation from 2003 to 2005 is presented in d. MSL = mean sea level relative to the CGVD28 vertical datum.

In general, one might be able to discern a decreasing trend in the rate of change in surface elevation with increasing elevation (Figure 4) but this trend is only strong over the November 2004 to May 2005 period and does also appear if the mean data are presented. Additional data are required for a complete statistical analysis. The literature supports a general decrease in sedimentation with increasing marsh elevation due to decreased frequency in tidal flooding. However, other studies conducted in the Bay of Fundy (e.g. van Proosdij *et al.*, in press; Davidson-Arnott *et al.*, 2002) demonstrate that frequency of inundation does not necessarily entrain higher sedimentation rates due to the impact of waves. In the current study, all of the sample stations are sheltered from wave activity, likely facilitating higher sedimentation rates. The sites however would be exposed to higher amounts of suspended sediment concentration during high wave periods which would effectively increase the availability of sediment to be deposited (van Proosdij *et al.*, 2001). This sediment would then be expected to be deposited within the quiescent region of the causeway channel.

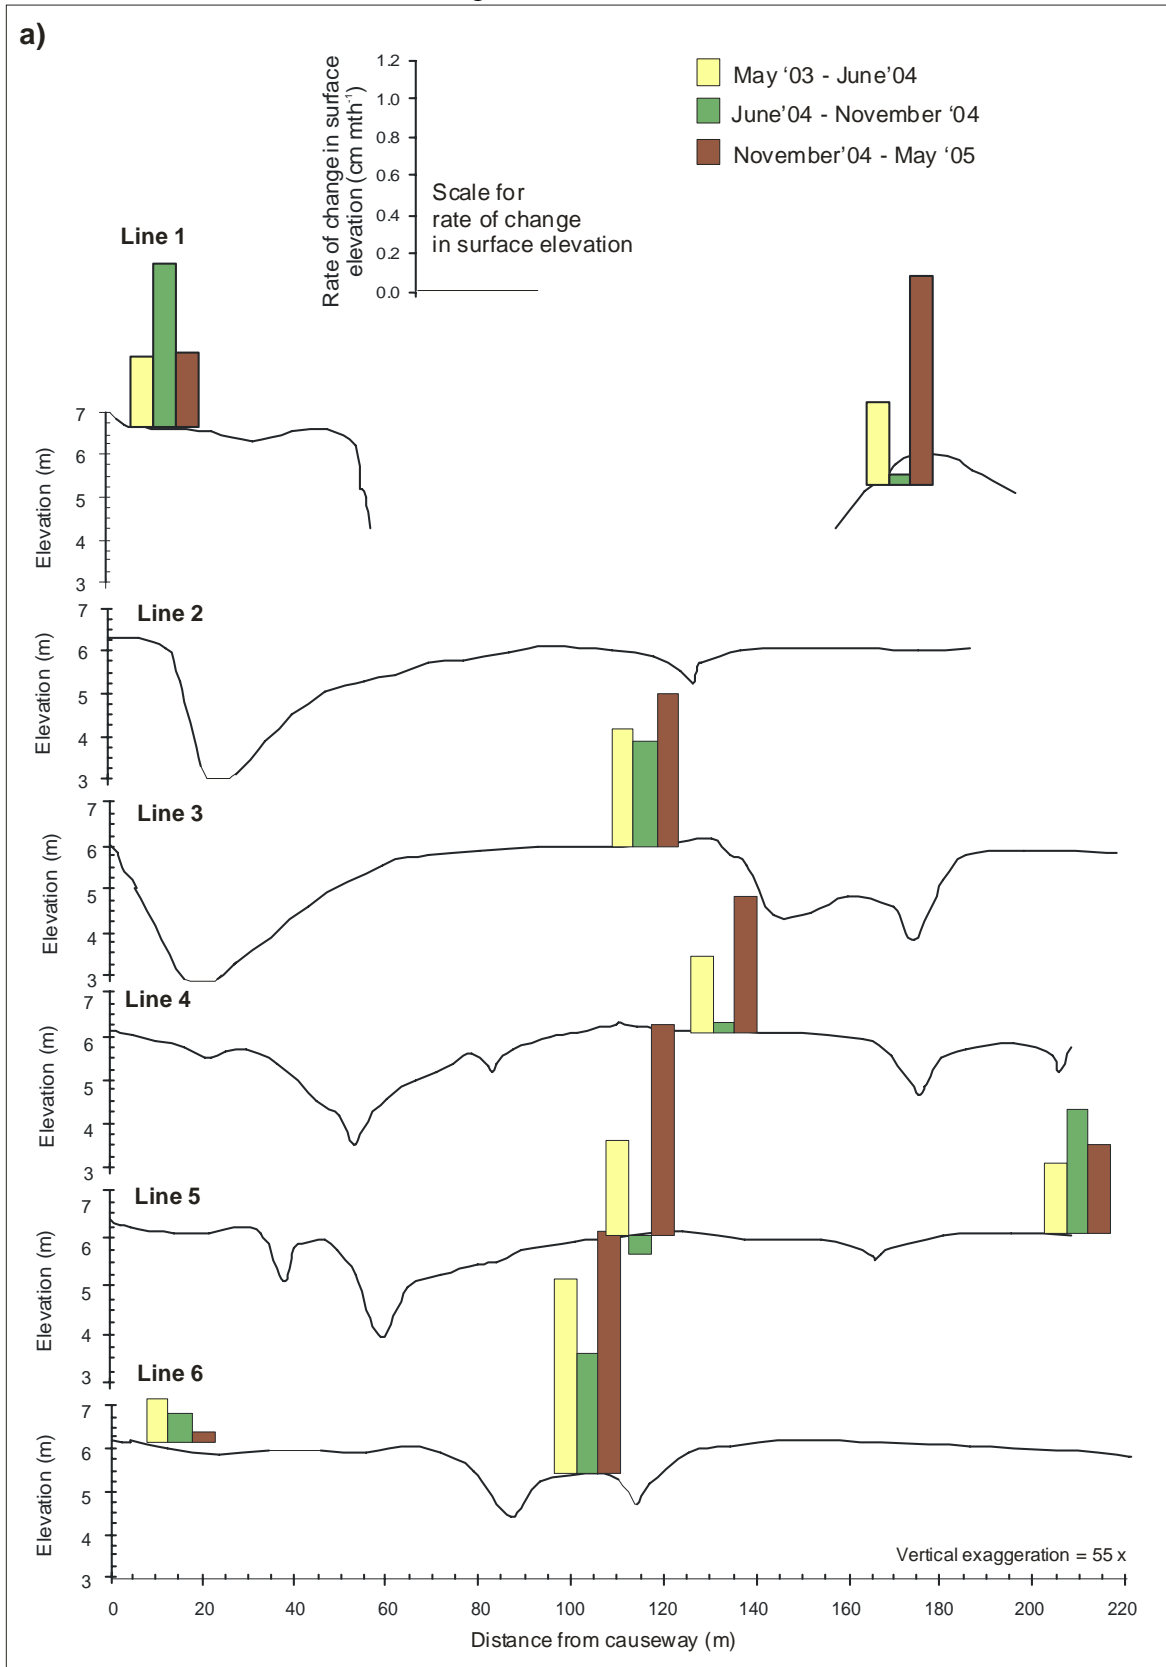
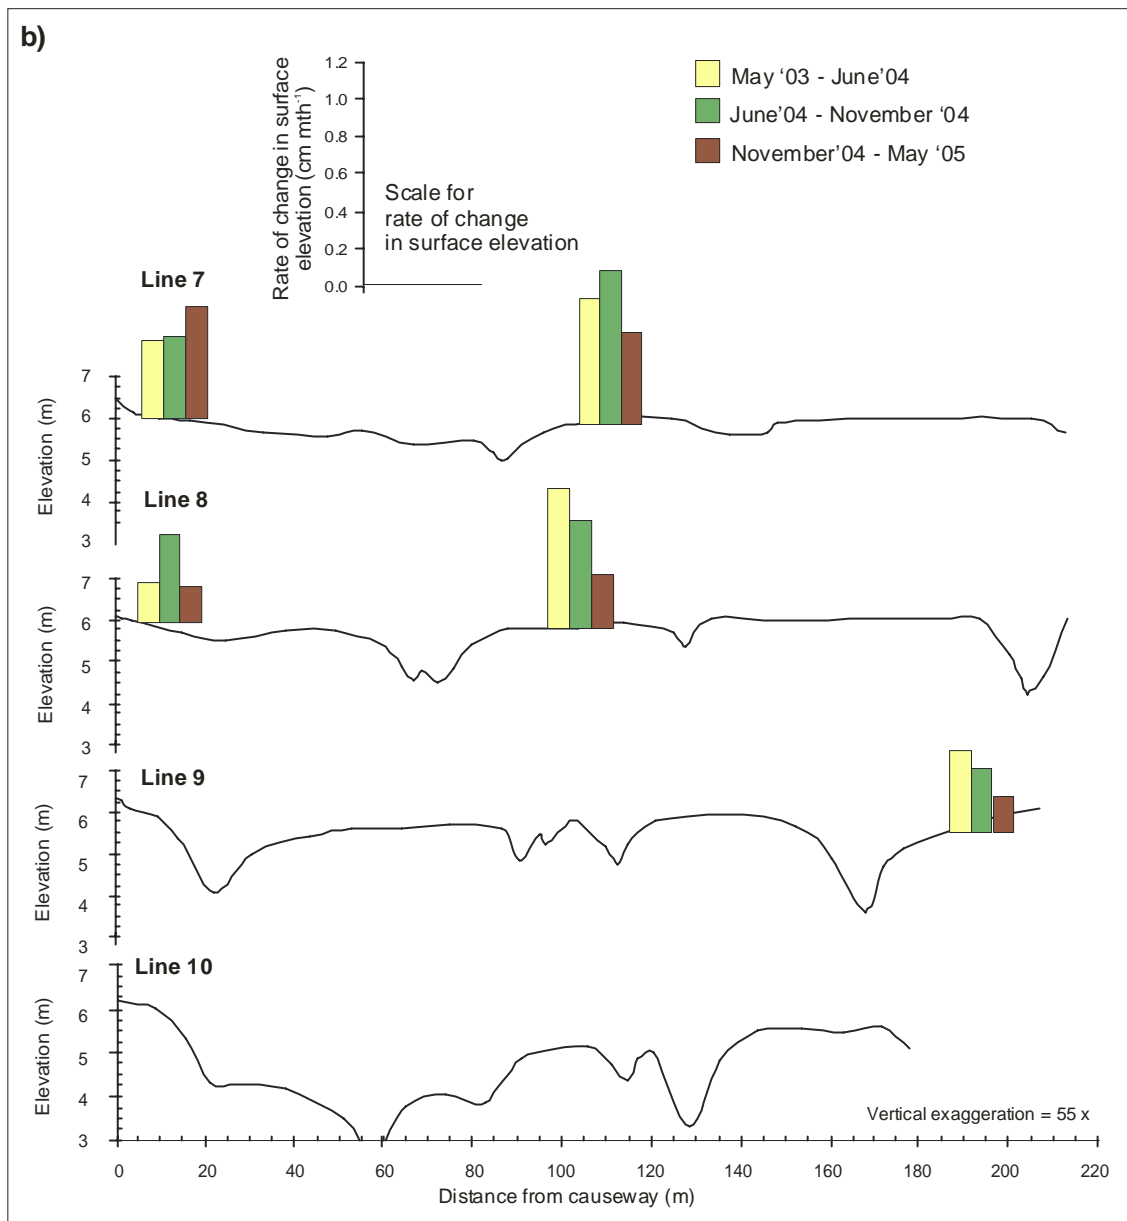
**Figure 5:** Rate of change in surface elevation at plate stations which survived the winter season. Topographic profiles are presented from the June 2004 survey for a) lines 1 to 6 and b) lines 7 to 10. Distance measured from base of causeway on marsh surface. Elevation is measured relative to MSL as defined by the CGVD28 datum. Depth of channel at line 1 not surveyed due to dangerous, unconsolidated nature of mudflat surface.

In order to examine the spatial patterns of sedimentation along the causeway channel, surface elevation change data were plotted over topographic profiles surveyed in June, 2004 (Figure 5). In general, there is a greater rate of change over the winter season for most lines except L8 and L9. This may be

attributed to a decrease in flooding frequency as the eastern section of the causeway channel continues to infill. Alternatively it might reflect a shift in the position of the creek channel thalweg and associated creek bank on Lines 8 and 9 (Figure 6).

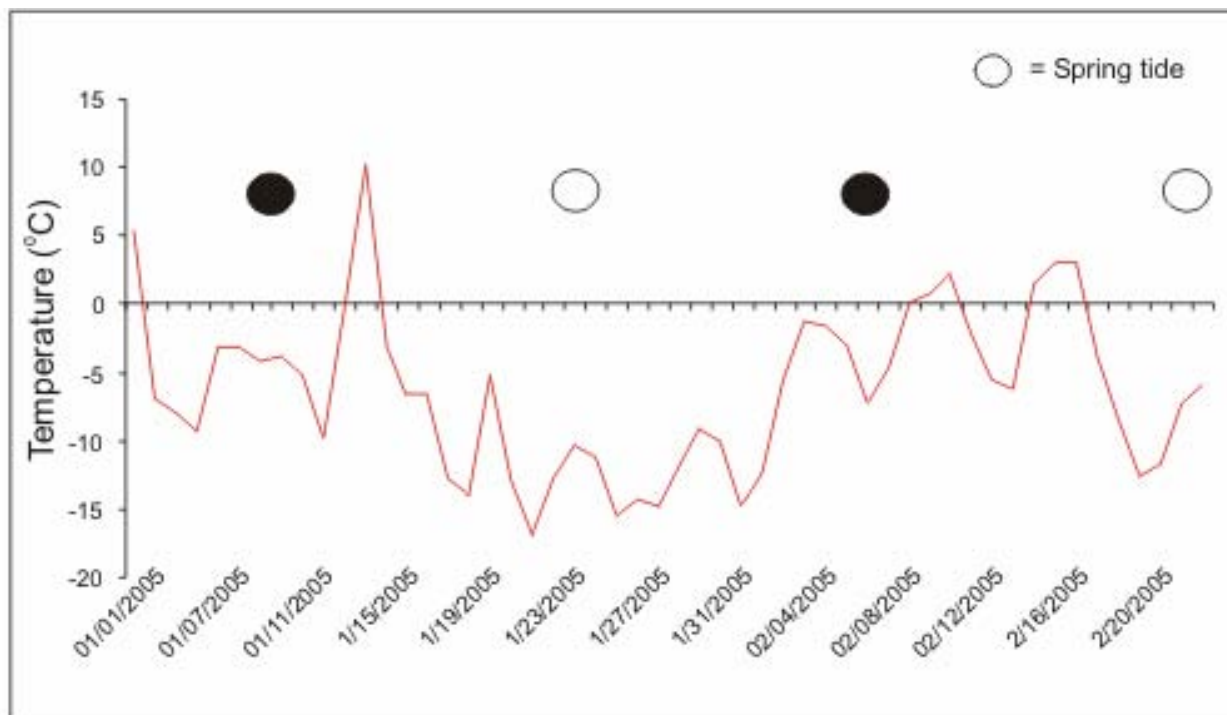
**Figure 6:** Temperature recorded at the Weatherhawk weather station at the Windsor tide gate for winter study and timing of spring tidal cycle. Filled and open circles represent old and new moons respectively.

In early January, small amounts of ice were observed by Ken Carroll (NSDAF) at the Windsor tide gate forming in the tidal creek channels during neap tides. By January 10, ice blocks were observed scattered over the marsh surface however strong NW winds moved ice off of the salt marsh surface during the high spring tides that night (Figure 6).

After February 17<sup>th</sup>, mean temperatures dropped significantly (Figure 6), freezing ice blocks to the marsh and mudflat surface (Figure 11). Subsequent spring tides with any wave action would have the potential to rip out marsh vegetation and their roots (Figure 12).

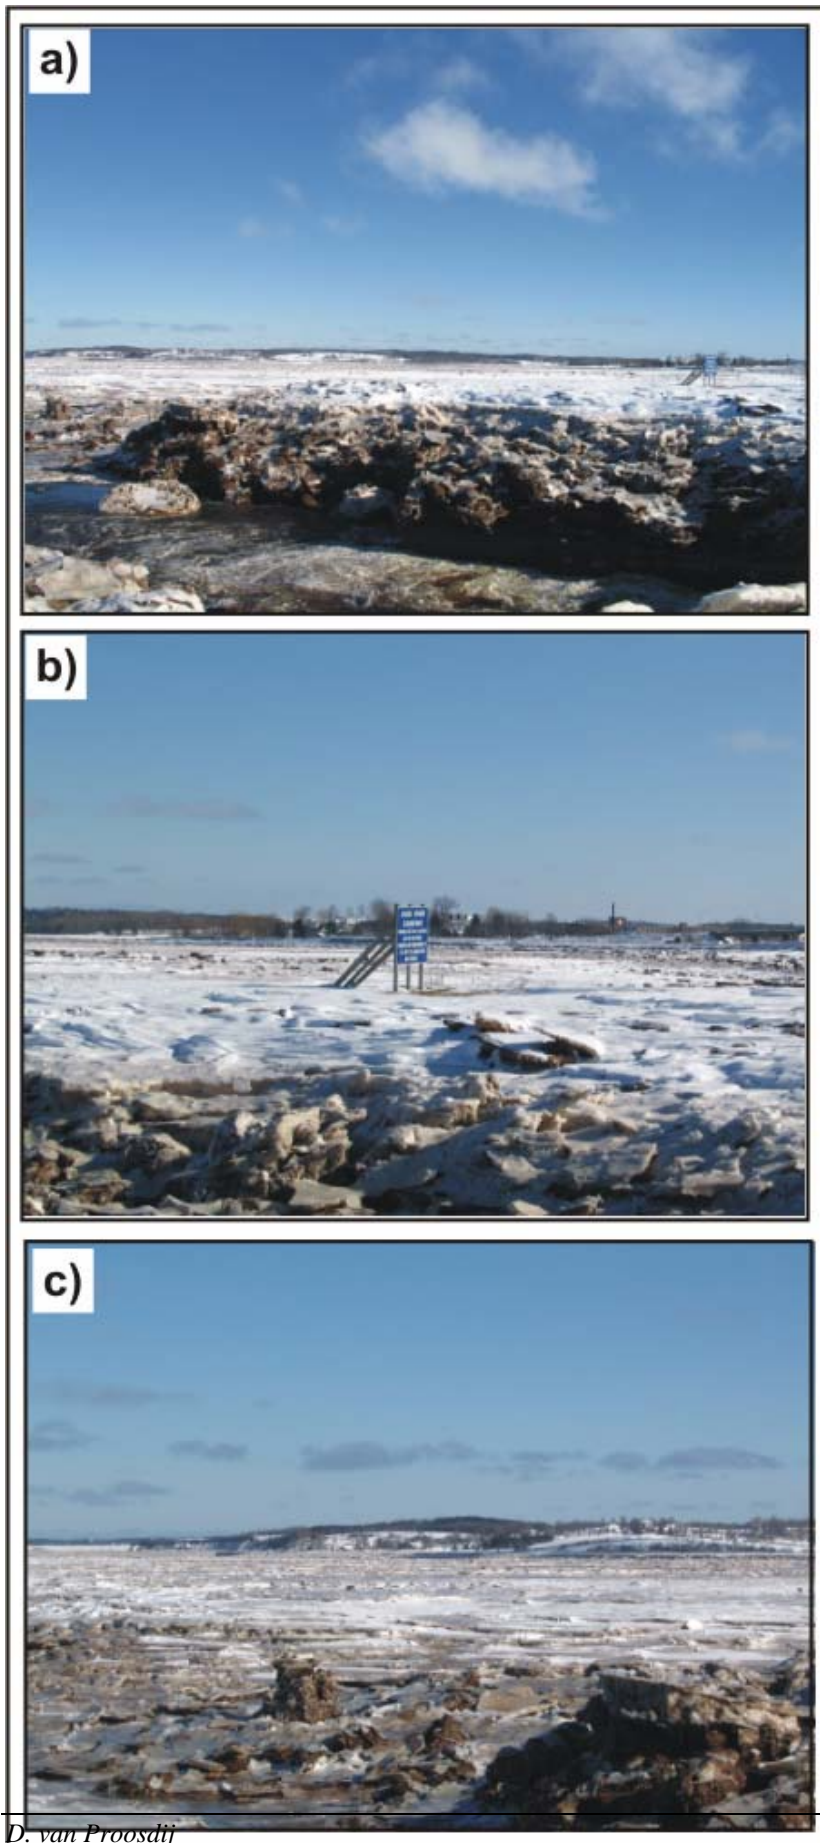
**Figure 7 (left):** Ice conditions on January 31<sup>st</sup>, 2005 at a) from tide gate, b) along causeway channel from tide gate and c) N towards main body of marsh from land near Avon River channel. Photos by K. Carroll, NSDAF.

of ice crust over the marsh surface. An additional 75 cm were deposited between January 20 and 24<sup>th</sup>, adding to the layer currently present. Spring tides on January 25<sup>th</sup> (Figure 6) broke up this crust and floating ice and snow ‘rafts’ were seen floating over the marsh surface. By January 31<sup>st</sup>, these rafts were observed over the entire marsh surface (Figure 7 and 8).

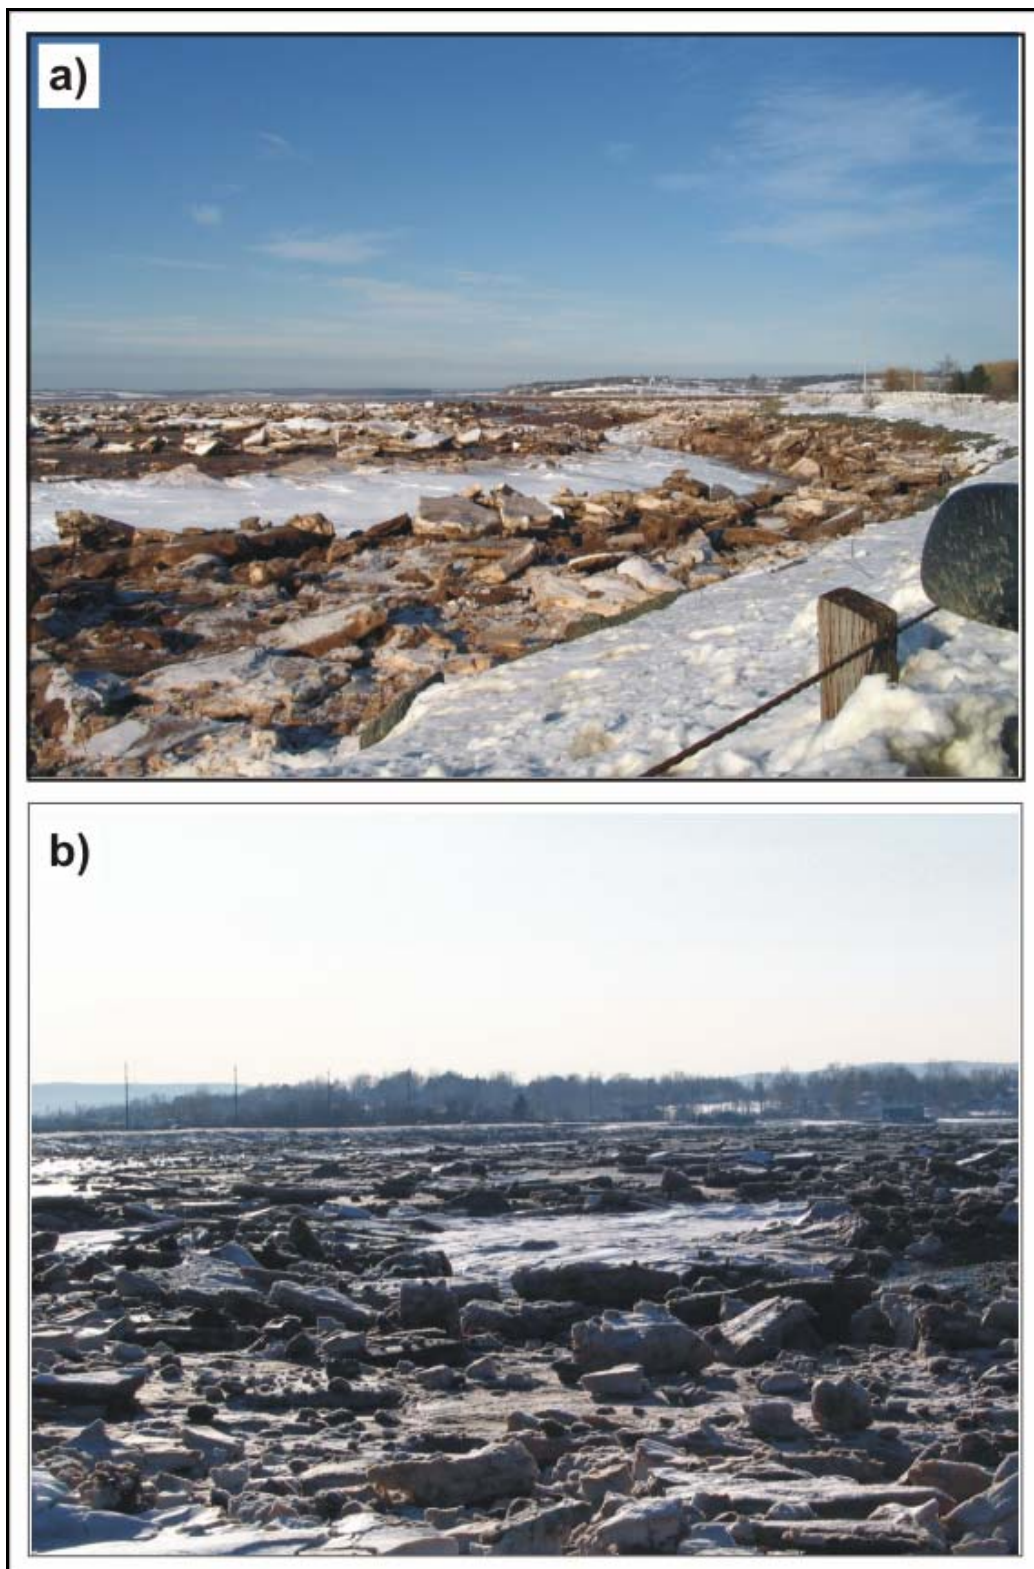
**Figure 8:** Ice blocks rafted in during spring tide near a) tourist bureau and b) along causeway channel looking west towards tide gate. Photos by K. Carroll.

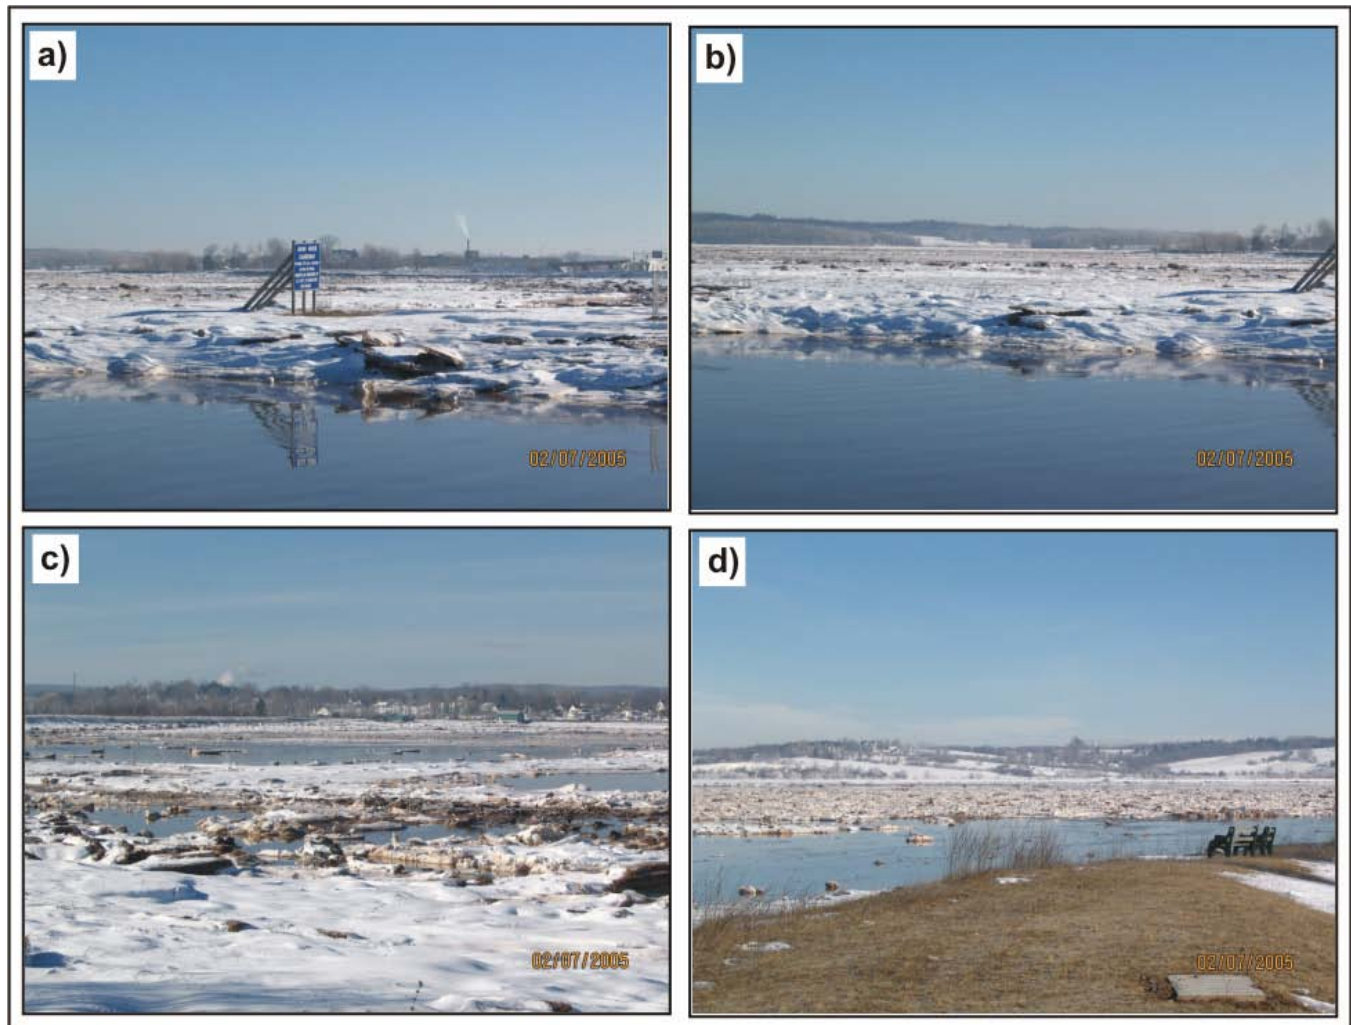
**Figure 9:** Winter conditions on Feb 7, 2005 on rising spring tide a) from tide gate towards causeway channel, b) from tide gate out to main body of marsh, c) from east side of causeway looking west toward tide gate and d) from tourist bureau dyke towards NW corner of marsh. Photos by K. Carroll, NSDAF.

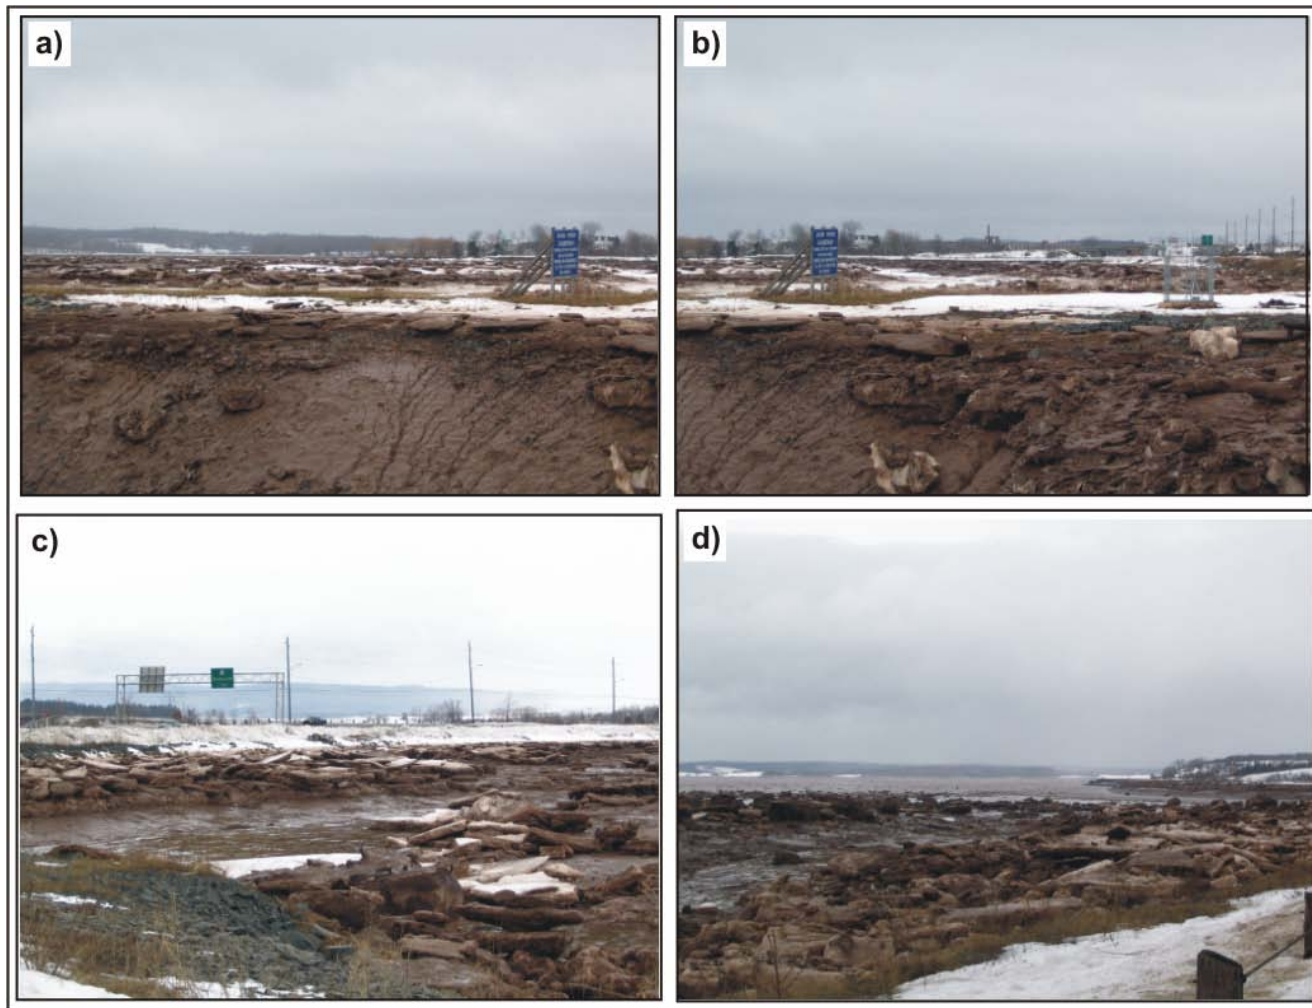
**Figure 10:** Winter conditions on Feb 11, 2005 after period of spring tides a) from tide gate out to main body of marsh, b) from tide gate towards causeway channel, c) from east side of causeway looking west toward tide gate and d) from tourist bureau dyke towards NW corner of marsh. Photos by K. Carroll, NSDAF. Note large ice pans which will remain on the marsh surface through the upcoming sequence of neap tides. In addition, layers of ice rafts can form steep sided banks along tidal creek channels as seen in photo C.

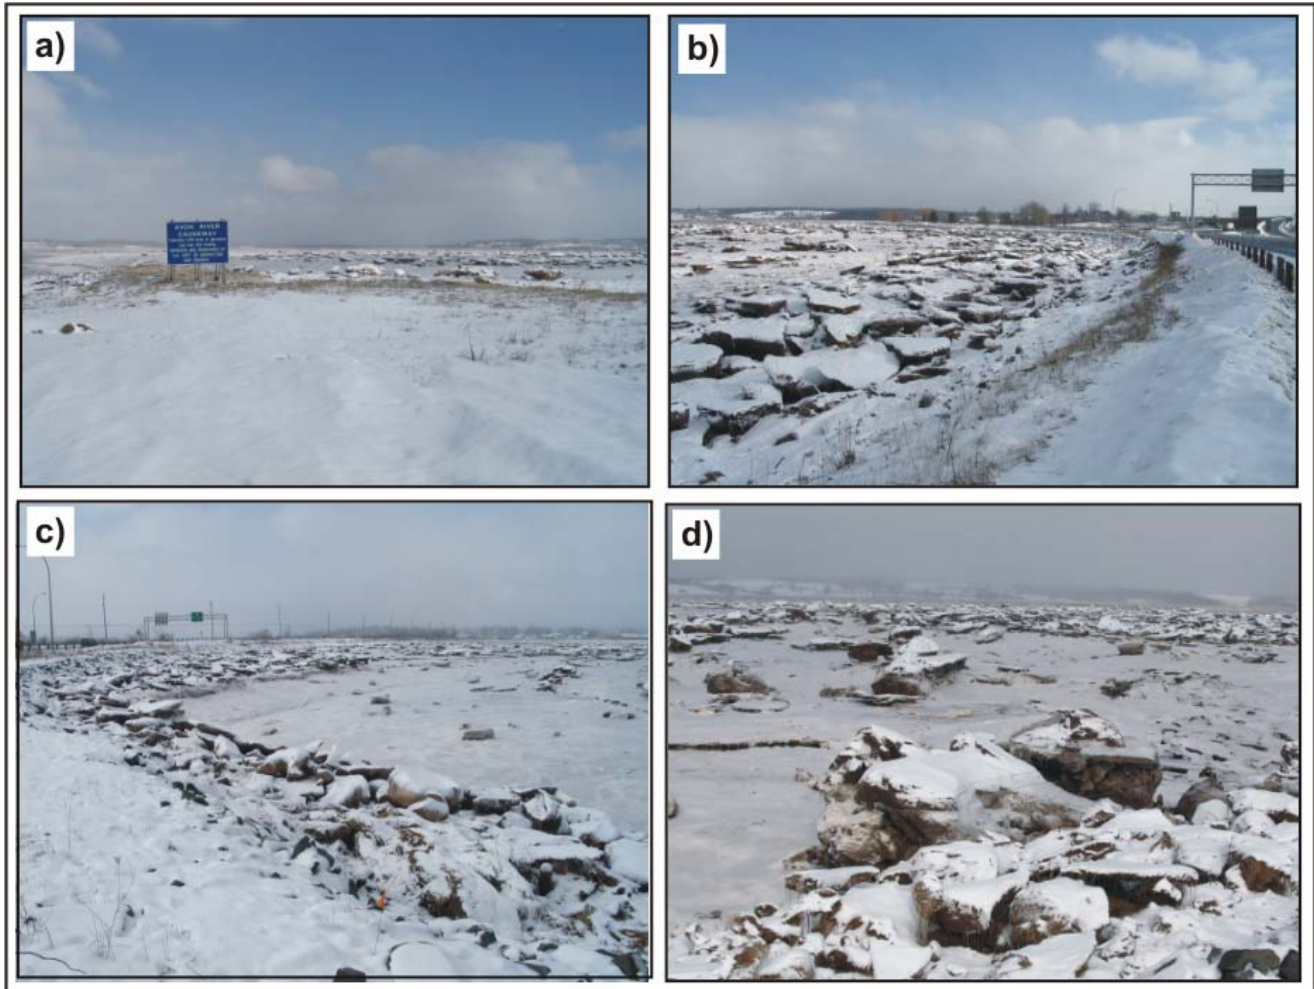
**Figure 11 (above):** Winter conditions on Feb 25, 2005 entering into spring tides a) from tide gate out to main body of marsh, b) from west end of causeway looking east long causeway channel, c) from east side of causeway looking west toward tide gate and d) from base of tourist bureau dyke towards NW corner of marsh. Photos by D. van Proosdij.

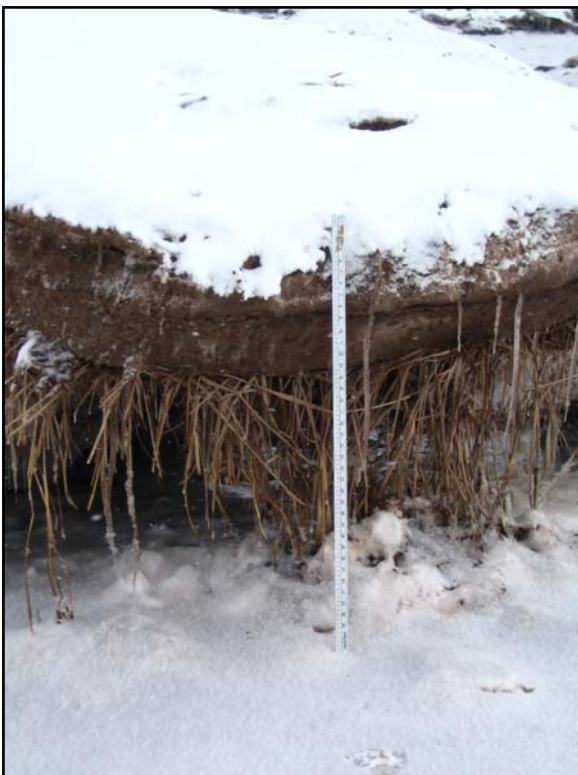
**Figure 12 (at left):** Drift ice with attached vegetative matter on Feb 25, 2005. The adhered vegetation in this example contains only dead above ground litter and does not contain root matter. Root matter is incorporated when an ice block freezes to the marsh surface and is later re-suspended on a spring tide, ripping out a mat of vegetation. This process results in depressions on the marsh surface which are evident in the spring particularly along the western and northern sections of the marsh. Photo by D. van Proosdij.

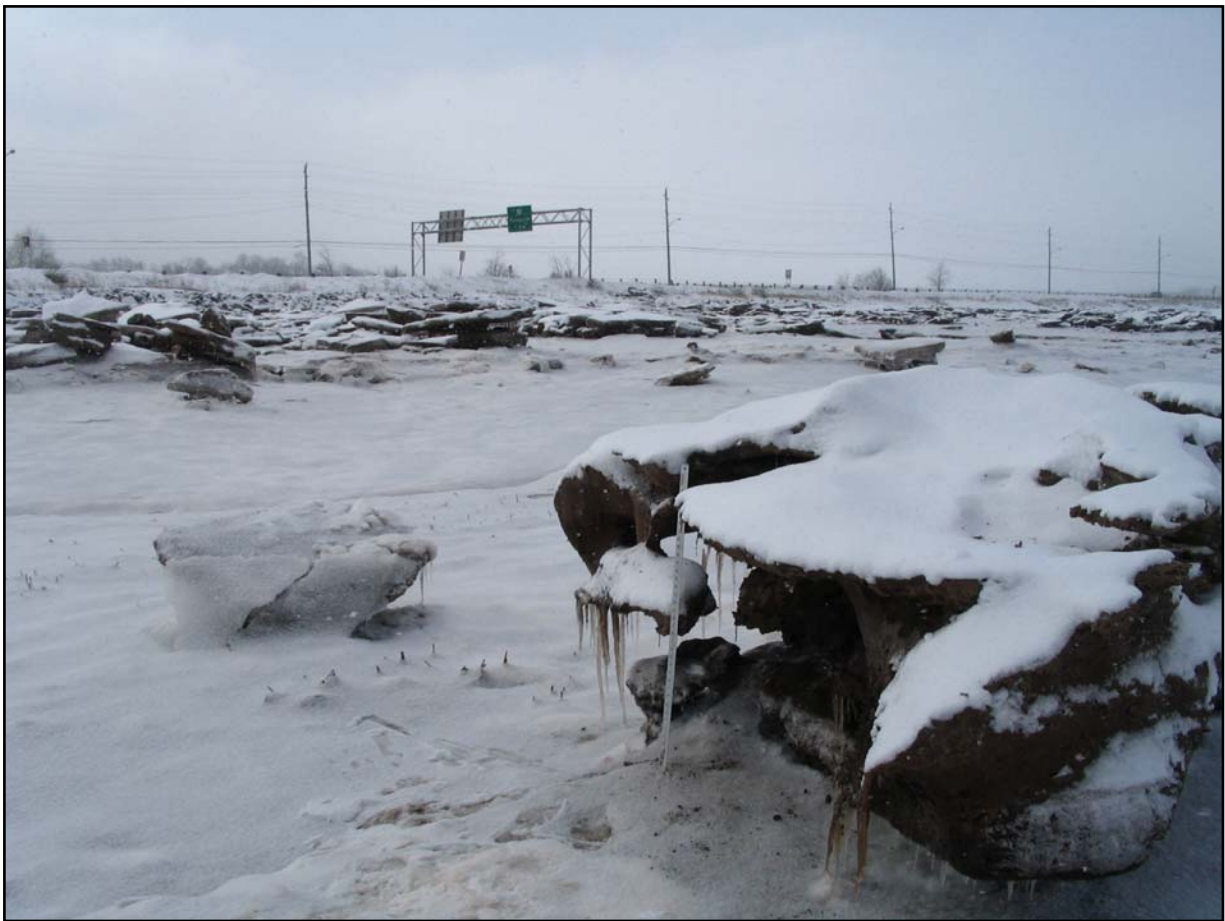
**Figure 13 (above):** Ice block near causeway channel. Meter stick for scale. Photo by D. van Proosdij, Feb 25, 2005

As mentioned previously, a number of ice blocks can coalesce over a series of tides, forming large amalgamations of sediment, ice and vegetative matter (Figure 13). Many of these exceeded 1.5 m in height and 2 m in diameter (Figure 14). Some may also include coarse sediment and rocks derived from the causeway toe itself.

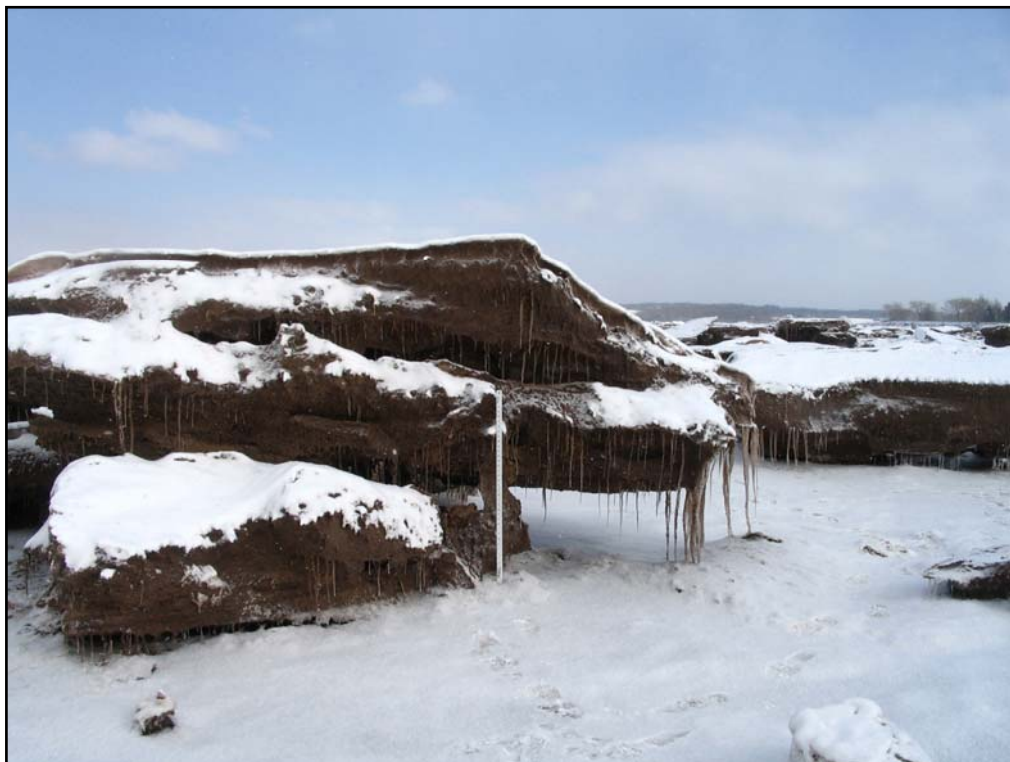
**Figure 14:** Layered shorefast ice block formed along causeway channel near L7-3sc. Note covering of ice by layer of sediment. Meter stick for scale. Photo by D. van Proosdij, Feb. 25, 2005.

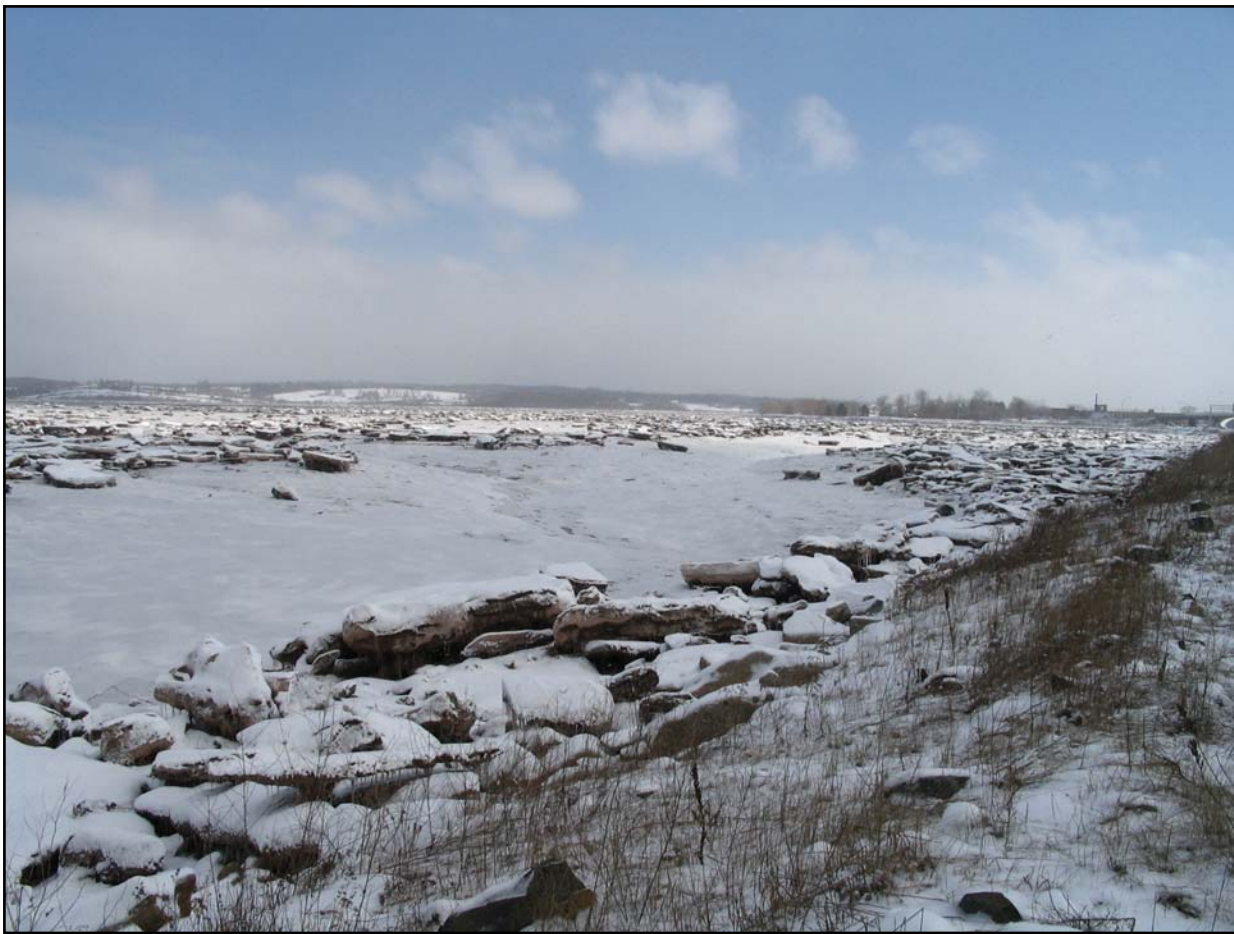
**Figure 15:** Drift ice along causeway tidal creek channel. Note the absence of ice in the central section of the channel since this area is flooded every tide. Photo by D. van Proosdij on Feb. 25, 2005.
